Missing Mandibular Third Molar from Line of Fracture: A Diagnostic Dilemma

Case Report

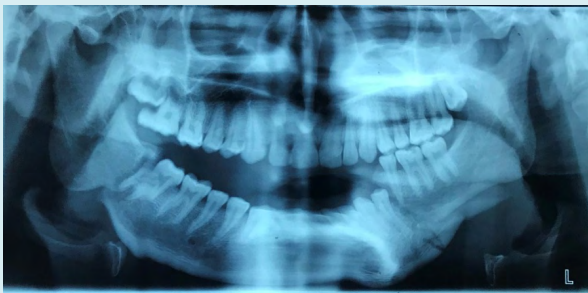
An 18 years old male patient reported to Emergency department of MP Shah hospital, with alleged history of RTA. On examination, the patient presented with multiple abrasions over left side of face, tenderness over the right angle and left body region of mandible, which was associated with restricted mouth opening. OPG was the only radiographic investigation done due to patient's financial constraints, which revealed vertically displaced right angle with tooth in fracture line and comminuted left body fracture of mandible (Figure 1).

Figure 1: Pre-operative Orthopantomogram.

When we compare post-operative and pre-operative OPG, pre-operative OPG revealed that there is one more image associated with crown portion of 17 and 18.

However, the most difficult motion artifact to be detected is a combination of 1 to 2 cm horizontal and 1 to 2 cm vertical movement during exposure of the posterior region of the mandible. These slight horizontal and vertical movements create a radiograph that exactly mimics an impacted tooth

(Figure 1) and will be referred to as a motion pseudo impaction [9].

In the present case report, this might have happened while taking an OPG, which has led to formation of ghost image of 47 or 37 in fracture line leading to appearance of impacted third molar.

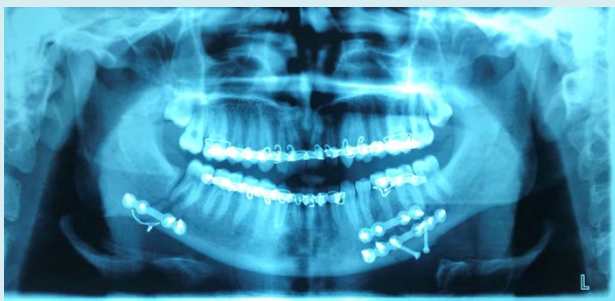
Postoperative OPG (Figure 2) showed adequate reduction and fixation of both fracture sites, but the tooth which was present in the line of fracture in the right-angle fracture was found missing. To rule out tooth displacement into the neck spaces, abdomen and lungs; lateral view of neck x ray (Figure 3), chest x-rays were advised and on radiographic interpretation there was no radiographic evidence of displacement of missing tooth.

Figure 2: Post-operative Orthopantomogram.

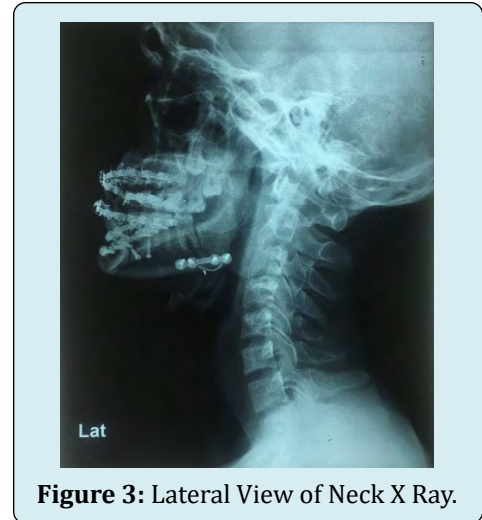
Figure 3: Lateral View of Neck X Ray.
